HYGEIA INC.

REPORT AND RECOMMENDATIONS OF THE SURVEY FOR ASBESTOS AND PCB-CONTAINING MATERIALS AT THE PROPOSED COMMONWEALTH CENTER DEVELOPMENT SITE, WASHINGTON STREET, BOSTON, MASSACHUSETTS

VOLUME ONE  
SURVEY REPORT OF  
ASBESTOS AND PCB-CONTAINING MATERIALS  
COMMONWEALTH CENTER DEVELOPMENT SITE  
BOSTON, MASSACHUSETTS

May 31, 1989

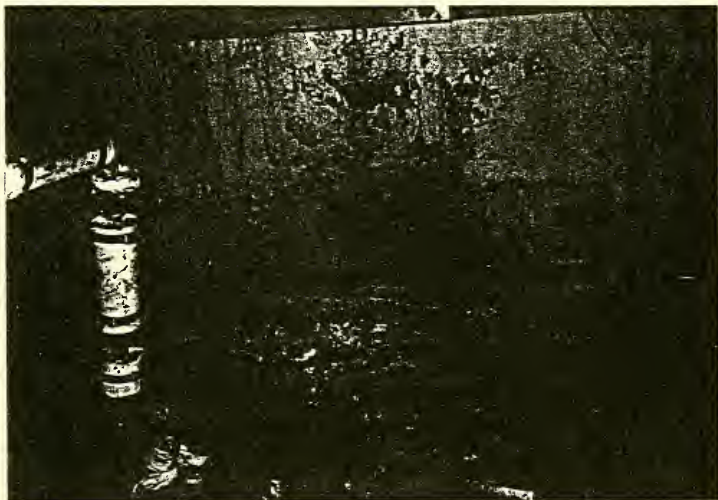
#1: Goodwill Basement - damaged pipe insulation

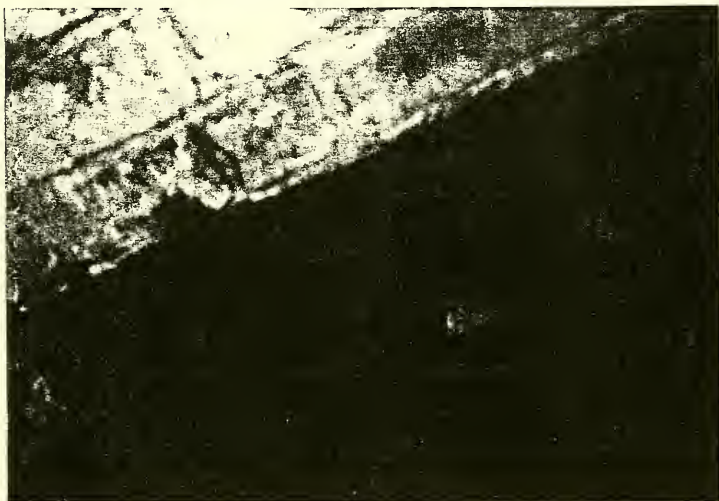
#1: View into pipe chase below tunnel from St. Francis House to Boiler Room

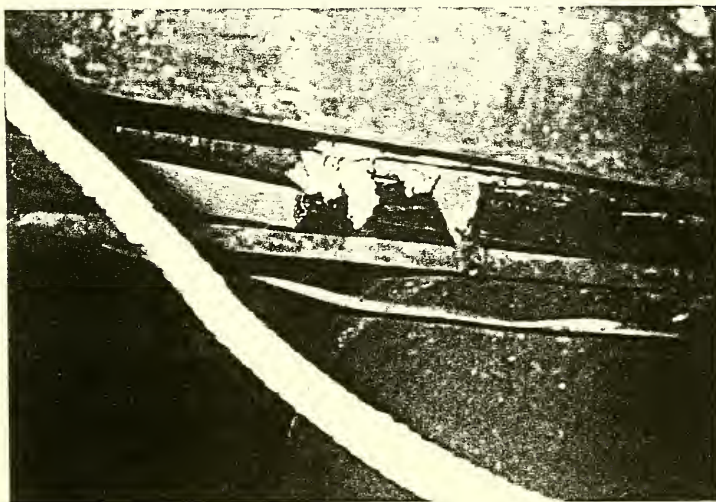
#4: Significantly damaged pipe insulation - tunnel from St. Francis House to Boiler Room

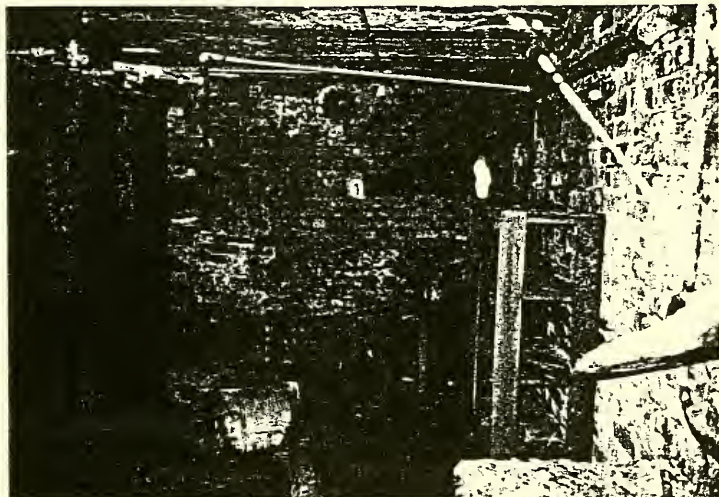
#5: Contaminated debris in storage room by entrance to Boiler Room

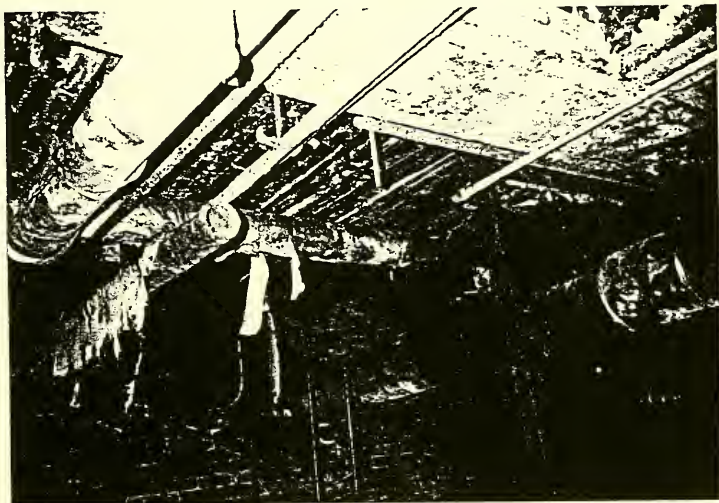
#7: Significantly damaged pipe insulation - Boiler Room

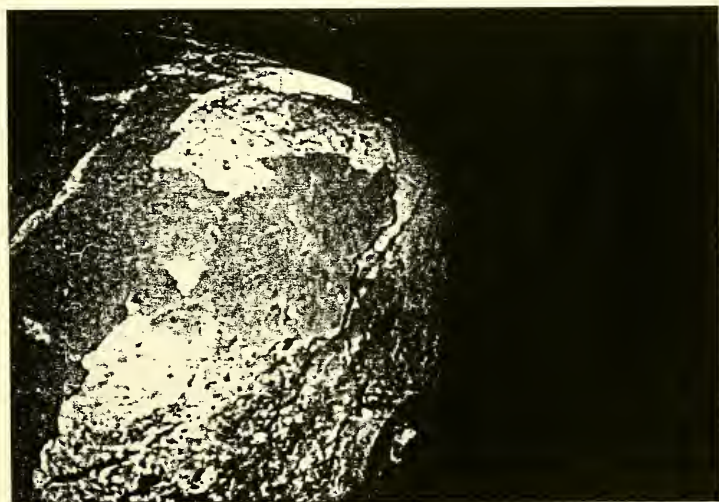
#8: Significantly damaged tank insulation - Boiler Room

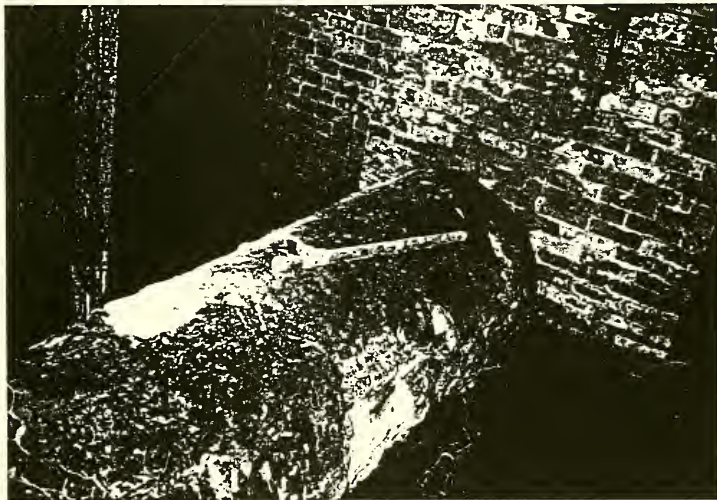
#9: Significantly damaged tank insulation - Boiler Room

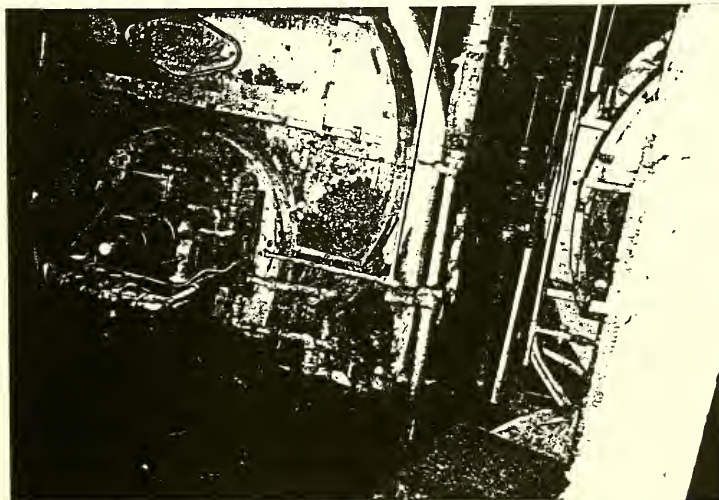
#10: Boilers with significantly damaged insulation - Boiler Room

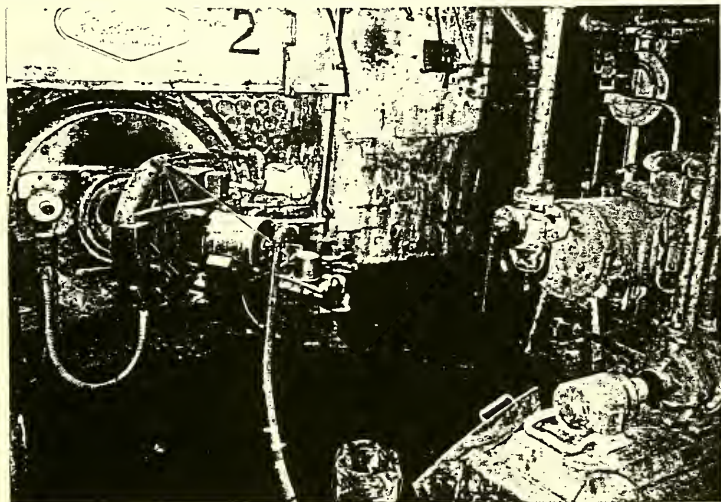
#11: Boilers with significantly damaged insulation - Boiler Room

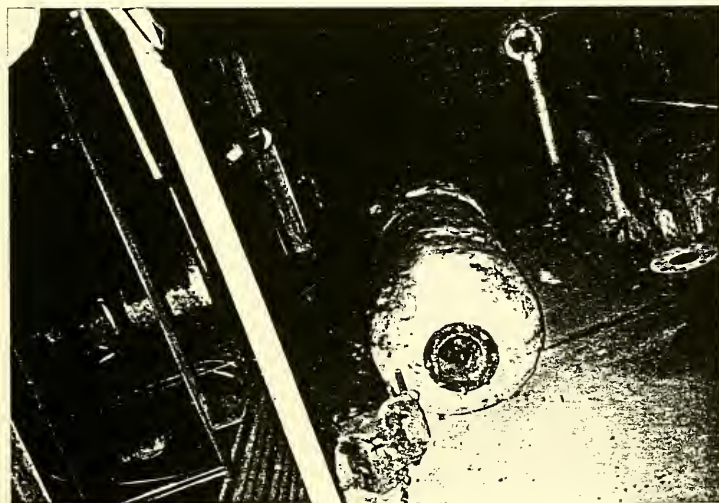
#12: Significantly damaged tank insulation - steam tunnel to right of Boiler Room

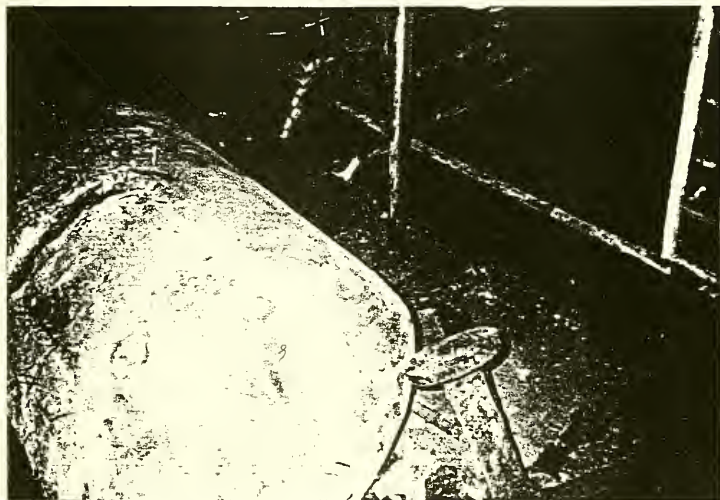
#13: Significantly damaged tank insulation - steam tunnel to right of Boiler Room

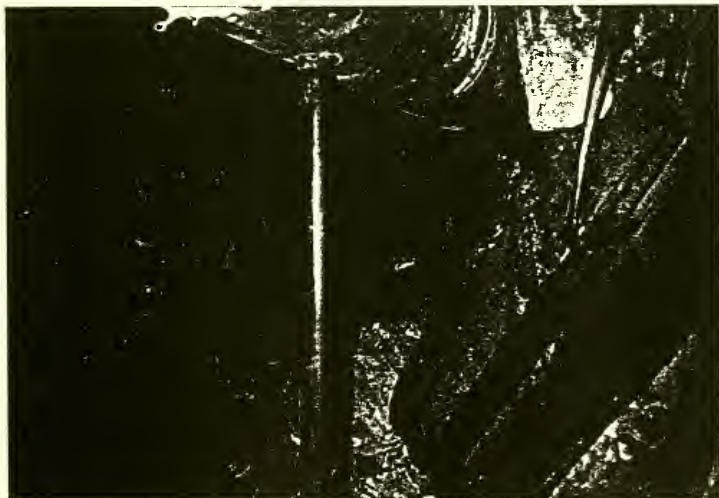
#14: Blocked end of steam tunnel to right of Boiler Room: no access

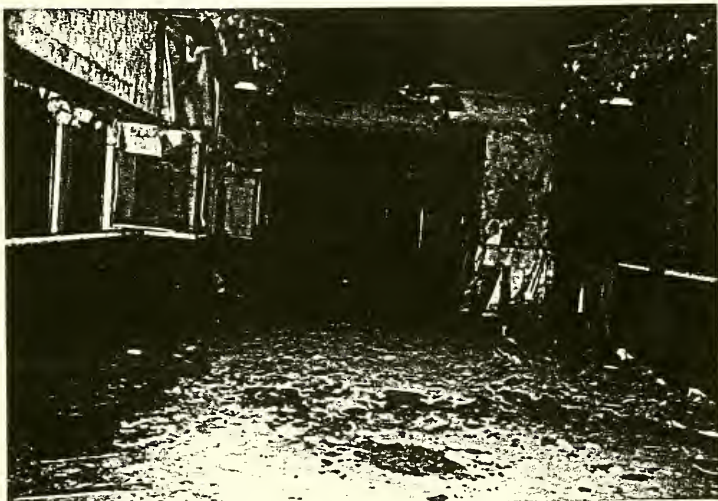
#1: View of first floor lounge showing contaminated ceiling debris on floor

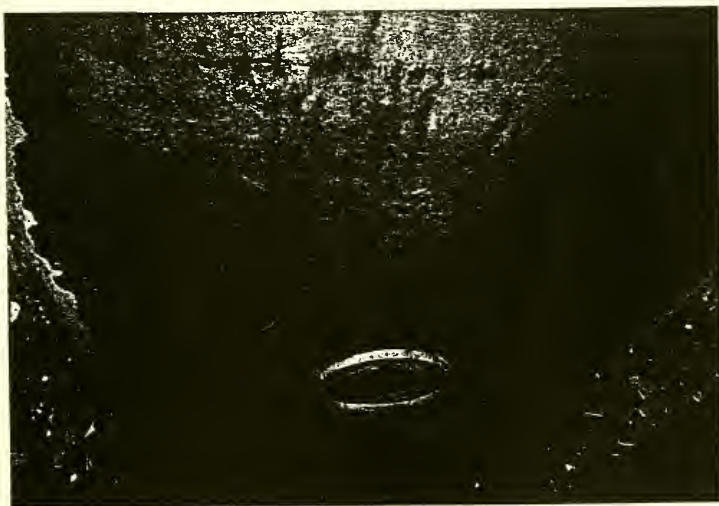
#2: View of water damaged ceiling of first floor lounge

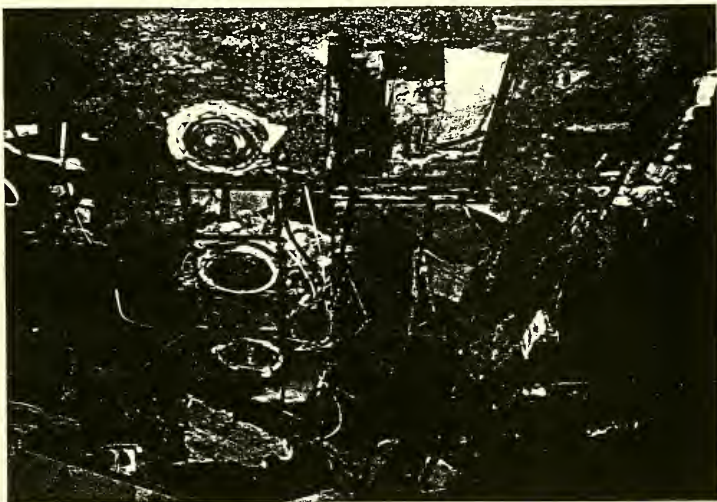
#3: View of water damaged duct insulation and ceiling - first floor lounge

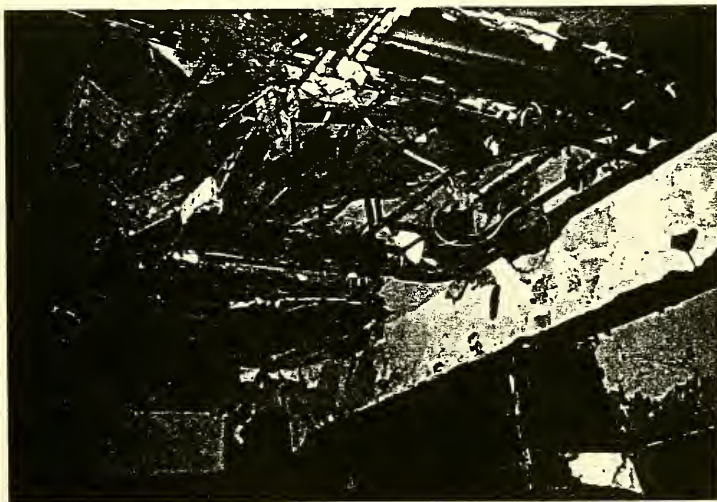
#4: View of water damaged duct insulation and ceiling - first floor lounge

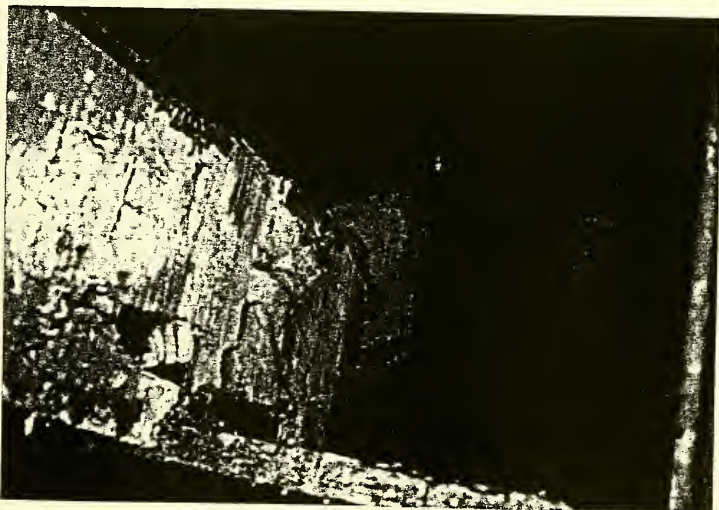
#8: Significantly damaged duct insulation - basement of first floor lounge

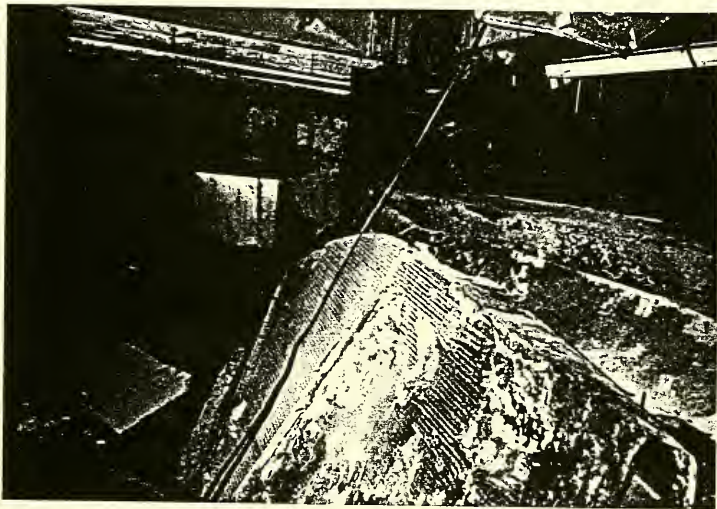
#9: Contaminated debris and demolished insulated ductwork on floor - basement of first floor lounge

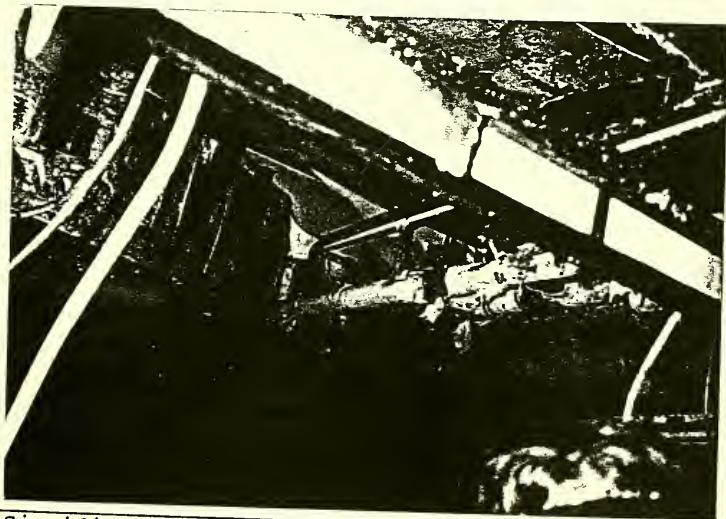
#14: Significantly damaged pipe and duct insulation - basement of first floor lounge

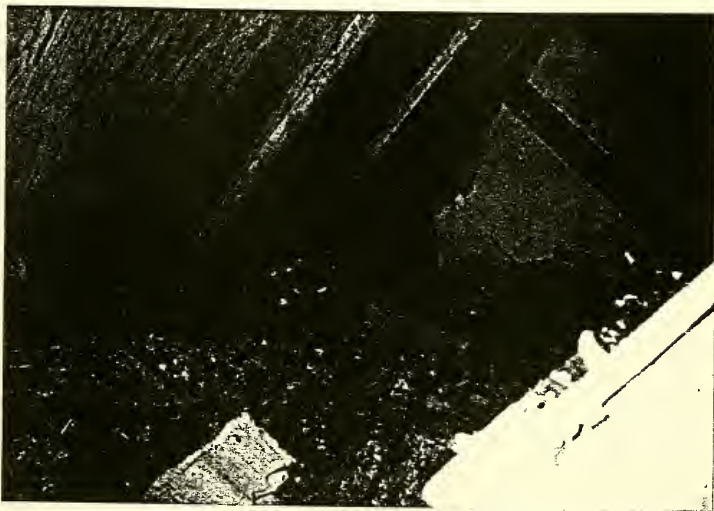
#15: Contaminated debris - basement of first floor lounge

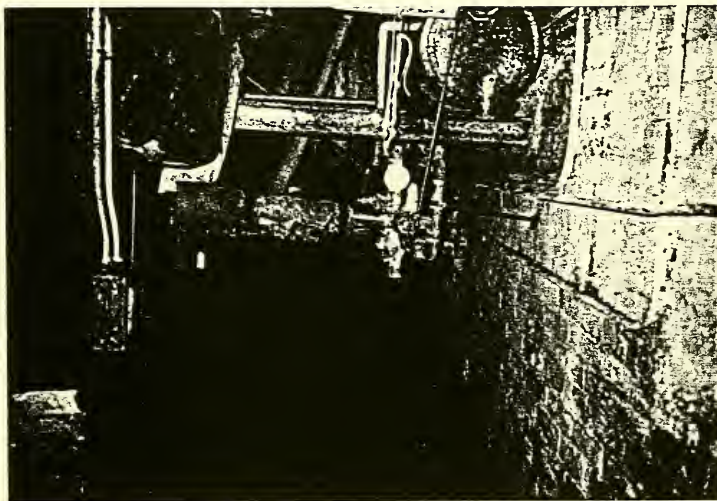
#17: View of Boiler Room showing tank and flooded area - sub-basement

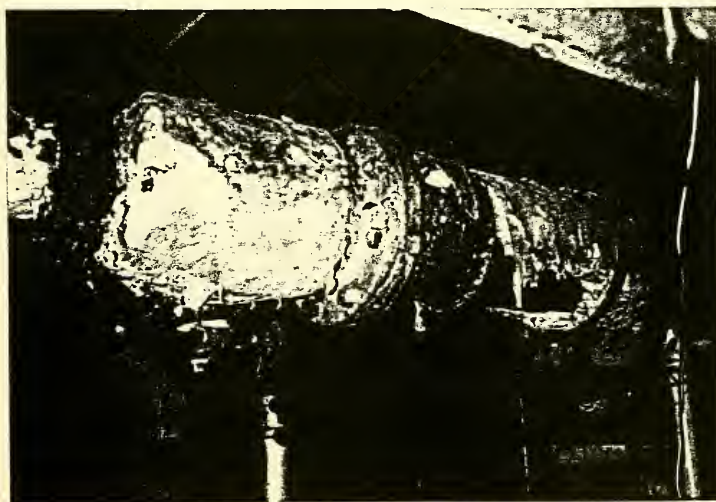
#18: Significantly damaged pipe insulation - sub-basement

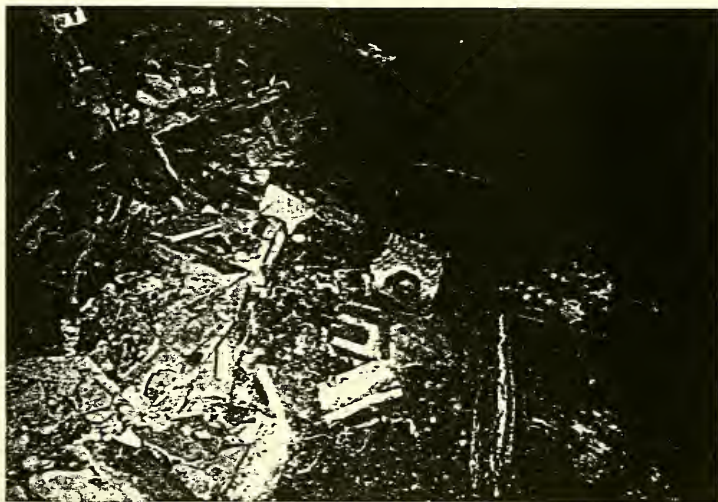
#19: Collapsed wall and contaminated debris - sub-basement

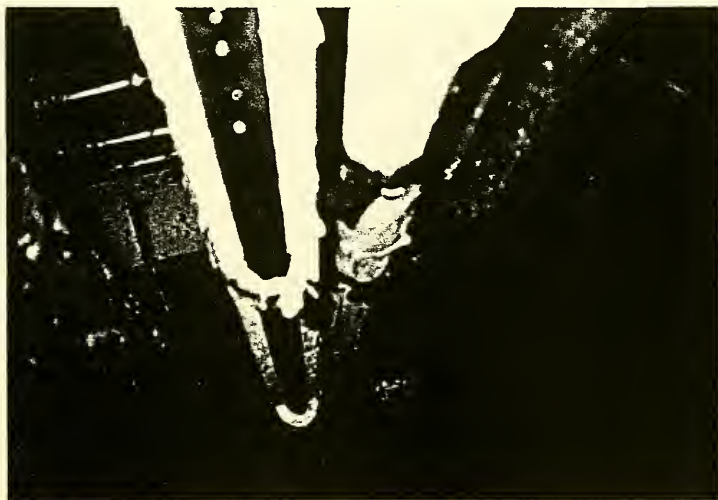
#20: Significantly damaged pipe insulation - sub-basement

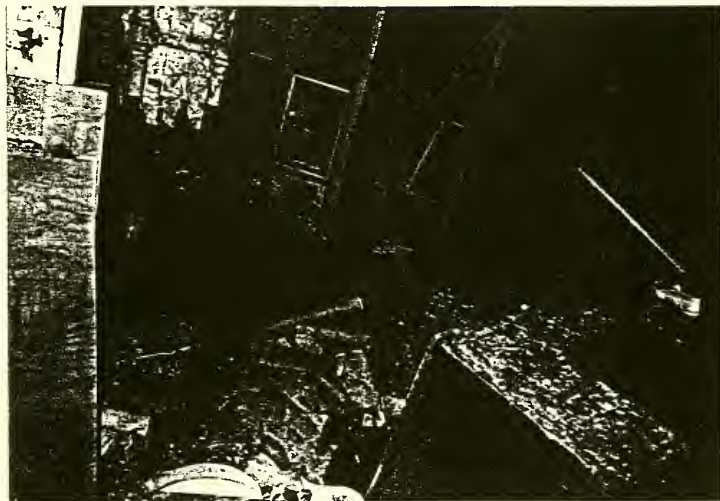
#21: Air conditioners, pipe insulation, and contaminated debris -  
basement

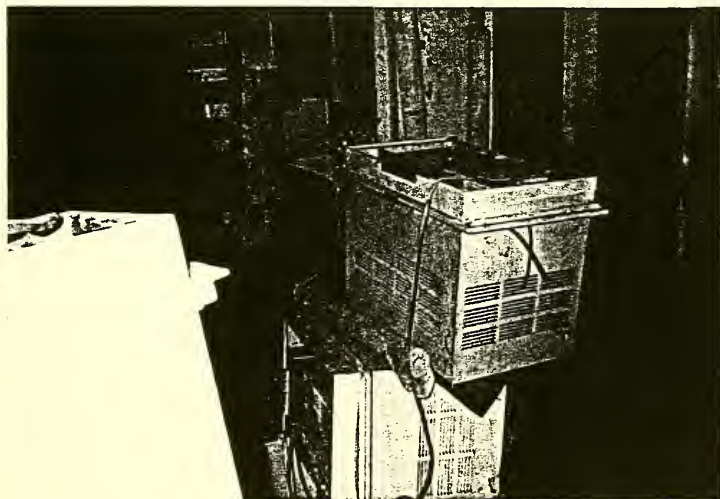
#22: Air conditioners, pipe insulation, and contaminated debris -  
basement

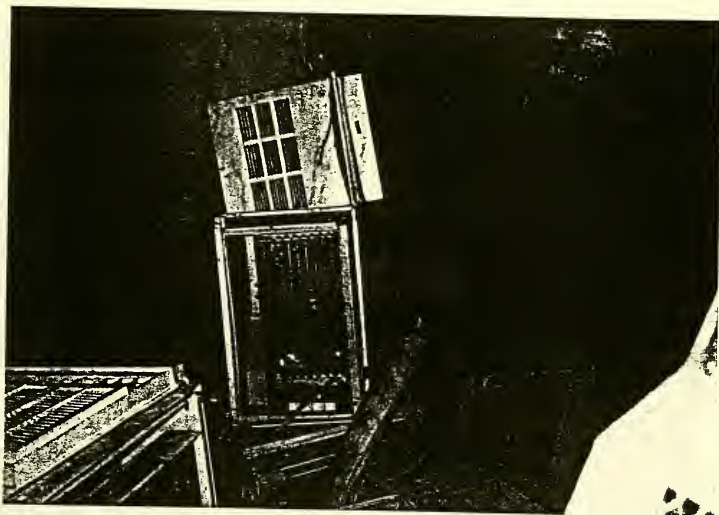
#23: Air conditioners, pipe insulation and contaminated debris -  
basement

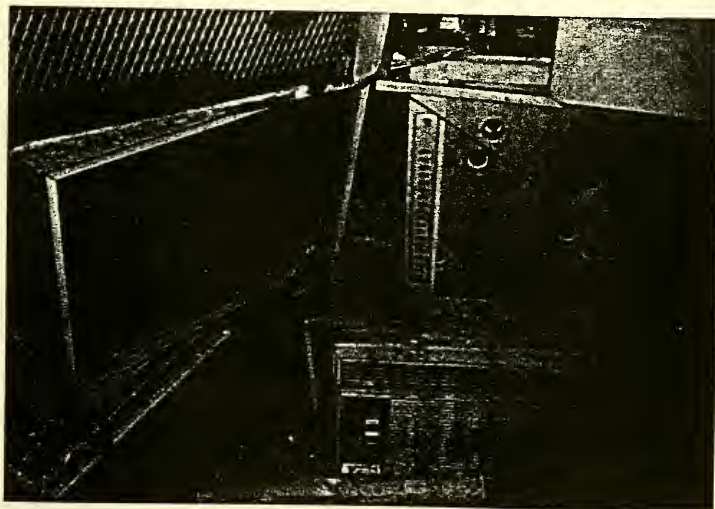
#24: Air conditioners, pipe insulation and contaminated debris -  
basement

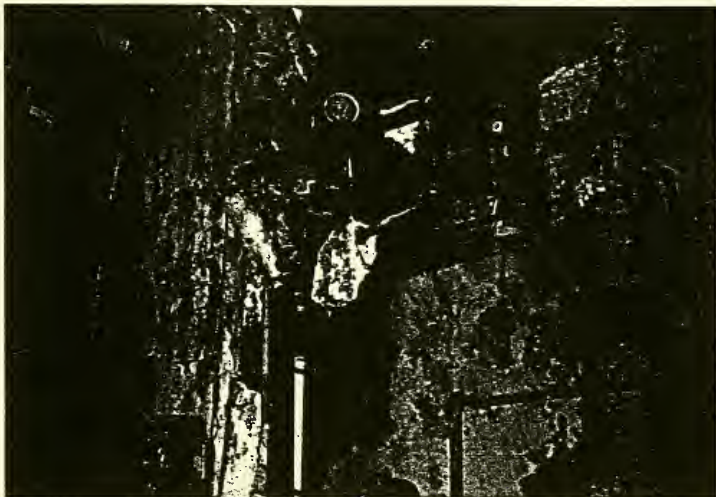
#25: Significantly damaged pipe insulation - basement

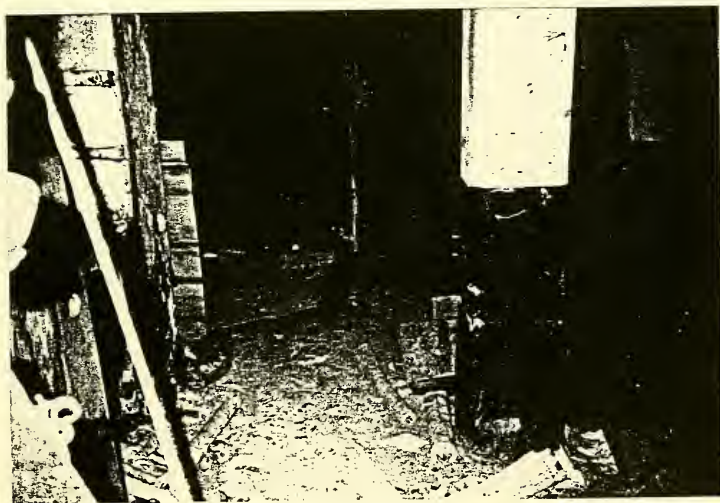
#26: Contaminated debris - basement

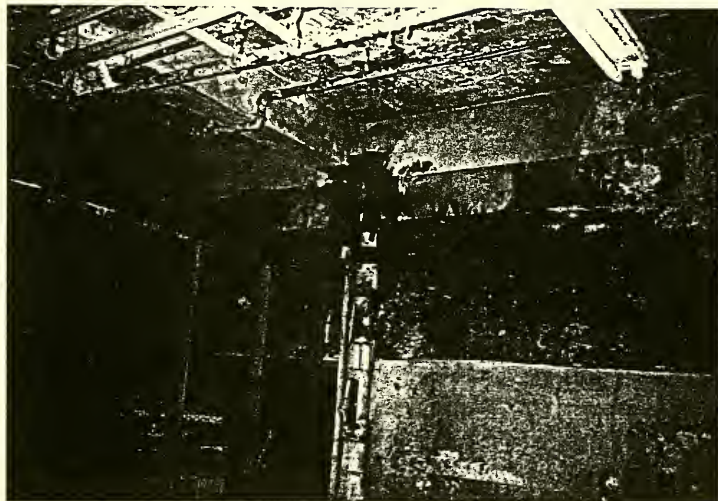
#31: Significantly damaged pipe insulation - basement

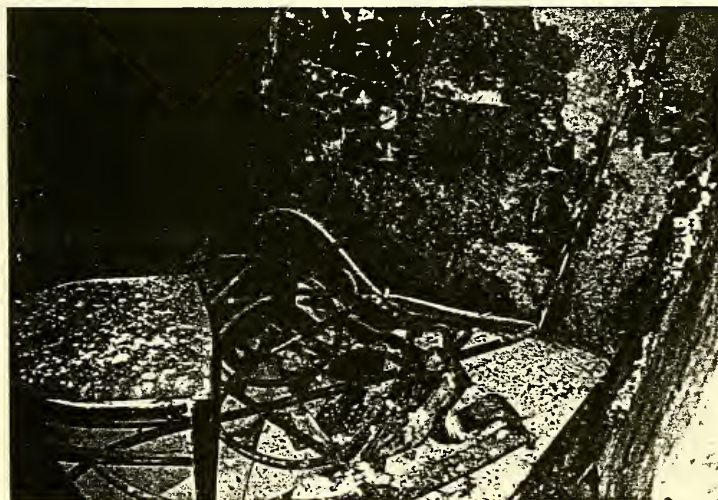
#32: Contaminated debris - basement

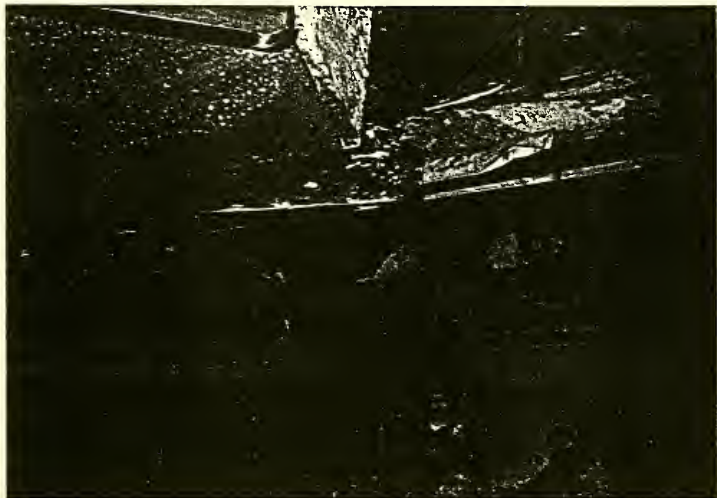
#33: Significantly damaged pipe insulation and contaminated debris - basement

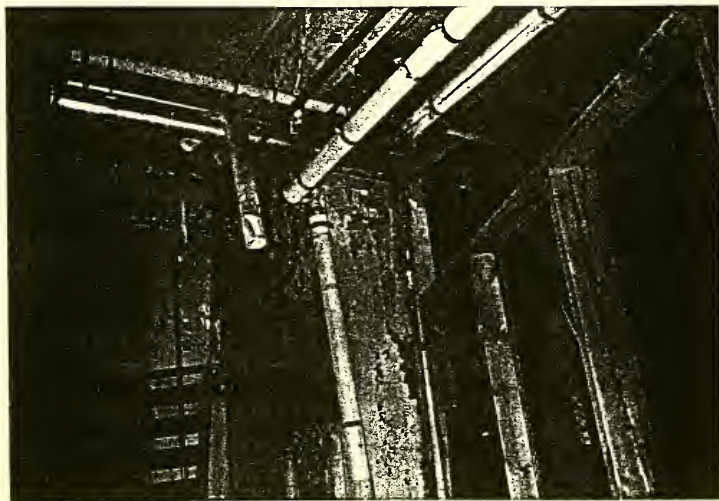
#39: Significantly damaged pipe insulation - basement

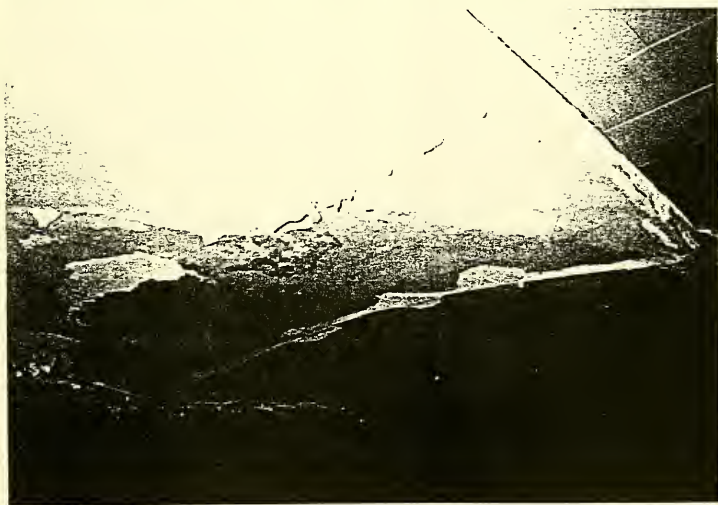
#40: Significantly damaged acoustical ceiling plaster - first floor

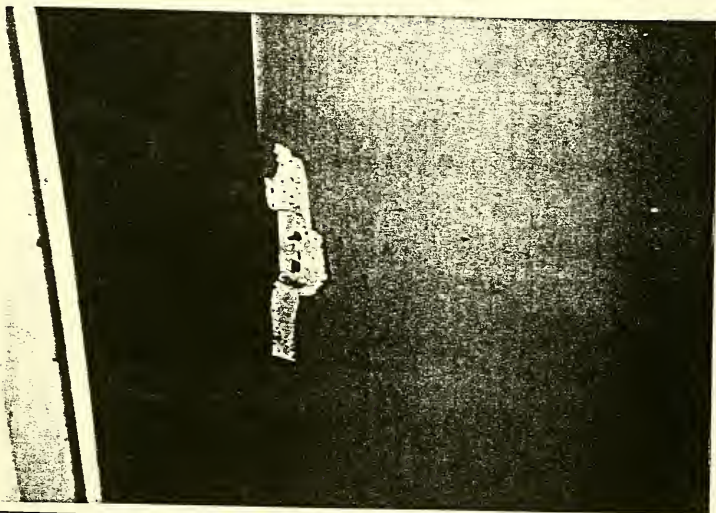
#41: Damaged fire door - second floor

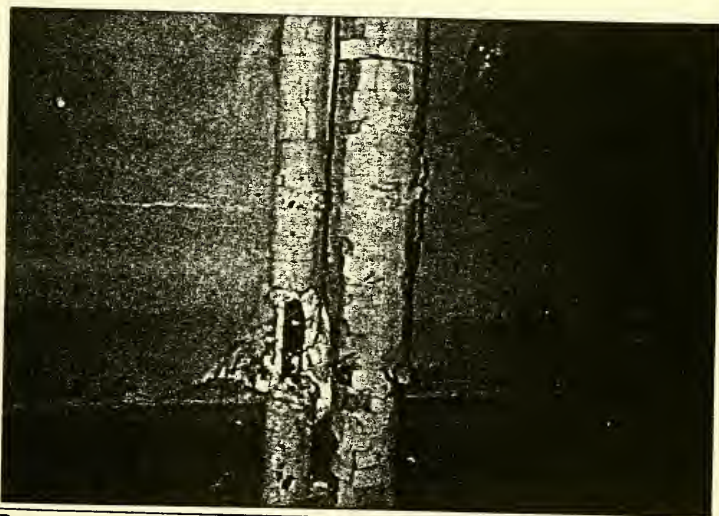
#42: Damaged pipe insulation - back section, third floor

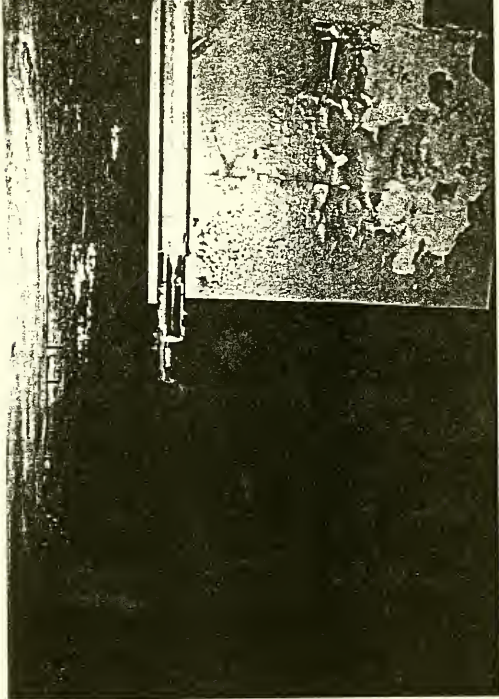
#43: Damaged pipe insulation - back section, third floor

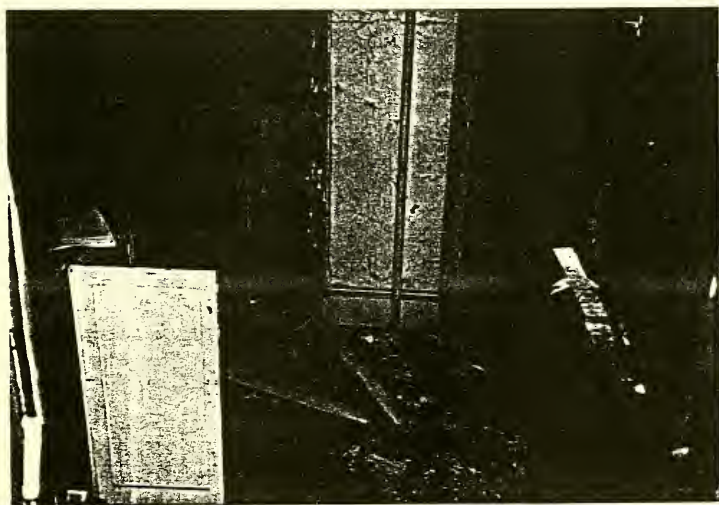
#44: Contaminated debris - back section, third floor
